Inspection Report

Company Phase Electrical Services

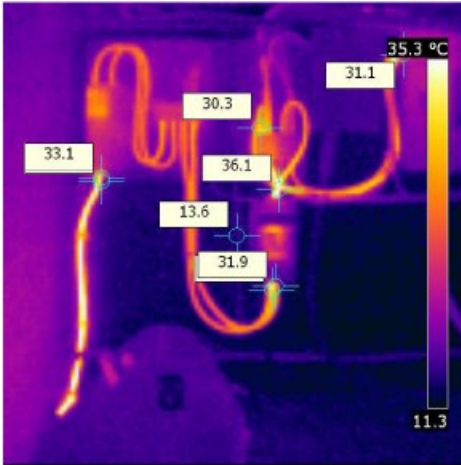
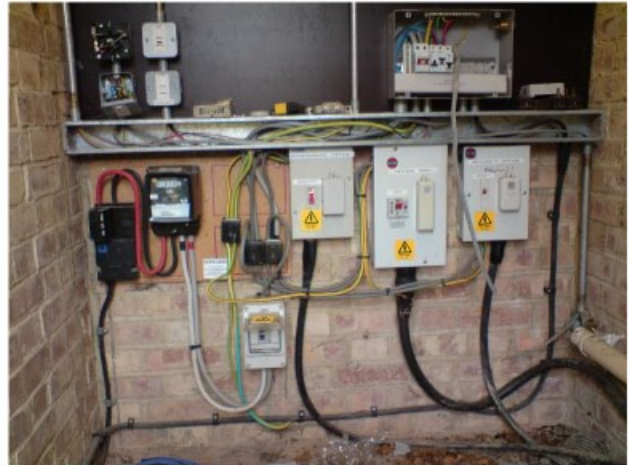
Image and Object Parameters		Text Comments
Camera Model	FLIR InfraCAM Wester	
Image Date	2008:10:20 11:51:14	
Image Name	IR_0369 incoming.jpg	
Emissivity	0.78	
Reflected Temperature	24.0 °C	
Object Distance	1.0 m

The incoming mains supply was tested under load, although during winter months more circuits will be on. Thermal image shows high heat levels through the mains supply.
